COMMENT TO THE STB BY MICHAEL A. TRUJILLO 1/17/2010
ENTERED
Office of Proceedings

28 West 5th Avenue, Antonito, Colorado

I will speak particularly to the condition of the bridges, the irrigation ditch bridges, the materials used for construction, the culverts, railroad crossings, maintenance and wetlands.

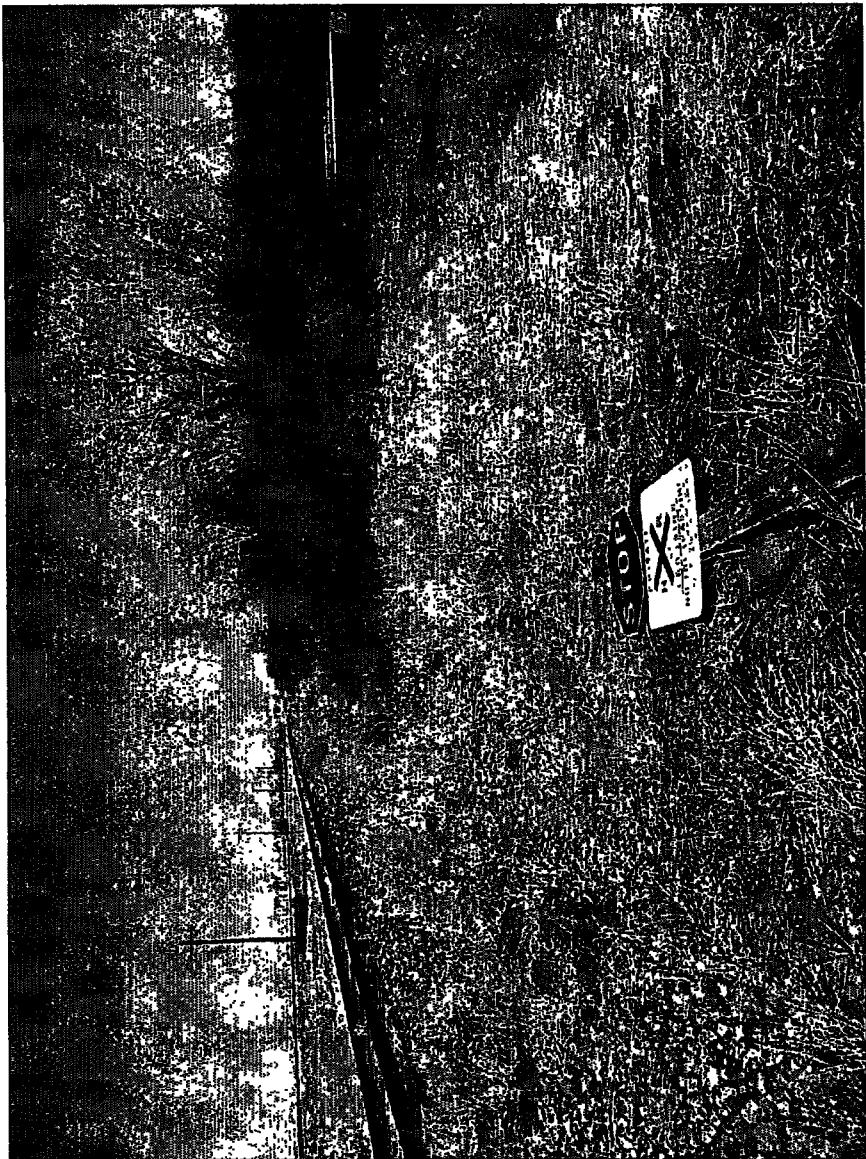
Metal stacks are expected to stabilize horizontally placed timbers which possibly act as a retaining wall to shore up existing disturbed soil and some ballast material.
